HIGH ARCH BRIDGE:
A COST BENEFIT ANALYSIS OF PRESERVATION TECHNIQUES AS APPLIED
TO A VERNACULAR CONCRETE STRUCTURE

Ann Marie DiLucia

A THESIS

1998

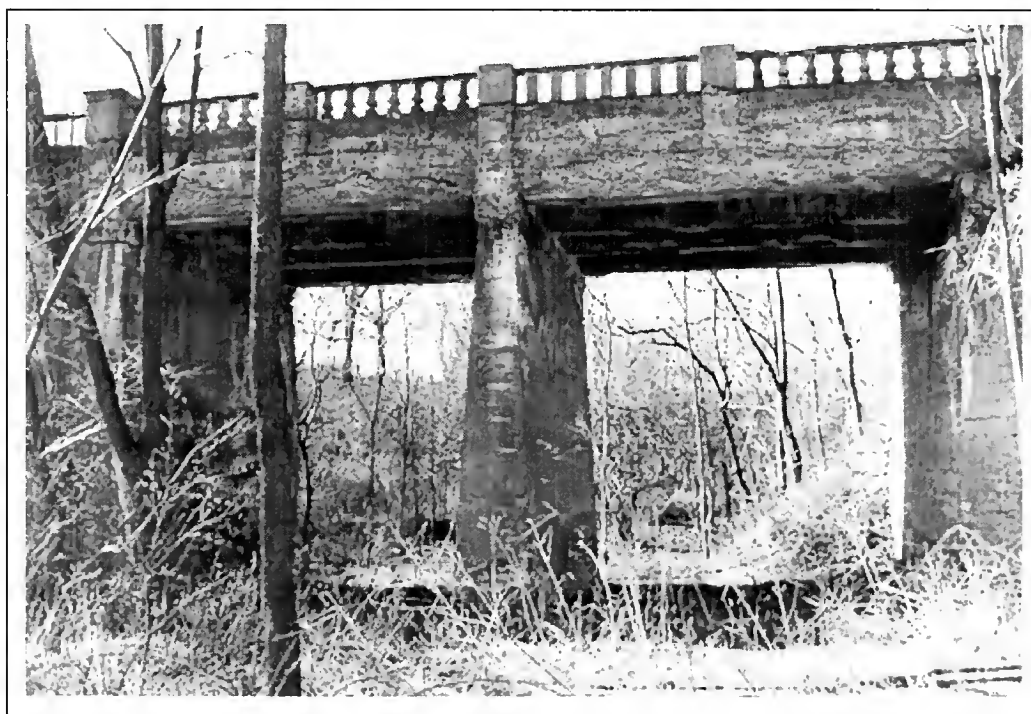
The bridge, 182' 6" end to end, is positioned north to south over the east-running Stony Creek, and consists of two straight spans and two concrete vaulted arches (Figure 2). Width of the bridge is 26' 6", with a roadway through it of 20' 9". The straight spans

Figure 2 Straight spans, east face.

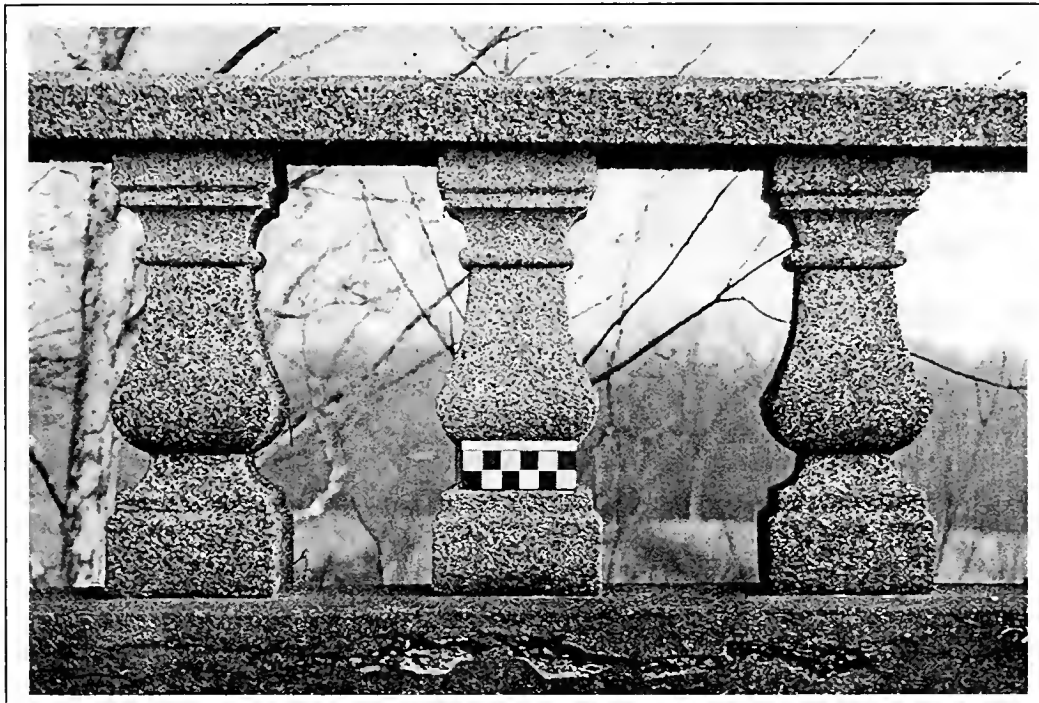
The northeast pylon is no longer in place, exposing a vertical strip of two inch to ten inch mixed aggregate. The top 14' of the northwest pylon is gone, leaving behind an area of impressive overgrowth and bird's nests. A parapet on the deck of the bridge contains eight large and eighteen small posts, evenly spaced amidst 180 balusters (Figure 4).

Figure 4 Balusters, east side of parapet.
